GROUP <b>Body</b>	MODEL <b>2012MY Rio (UB)</b>
	NUMBER <b>086</b>	DATE <b>December 2011</b>
<b>TECHNICAL SERVICE BULLETIN</b>		
<b>SUBJECT: RIO (UB) INSTRUMENT PANEL PAD NOISE REPAIR</b>

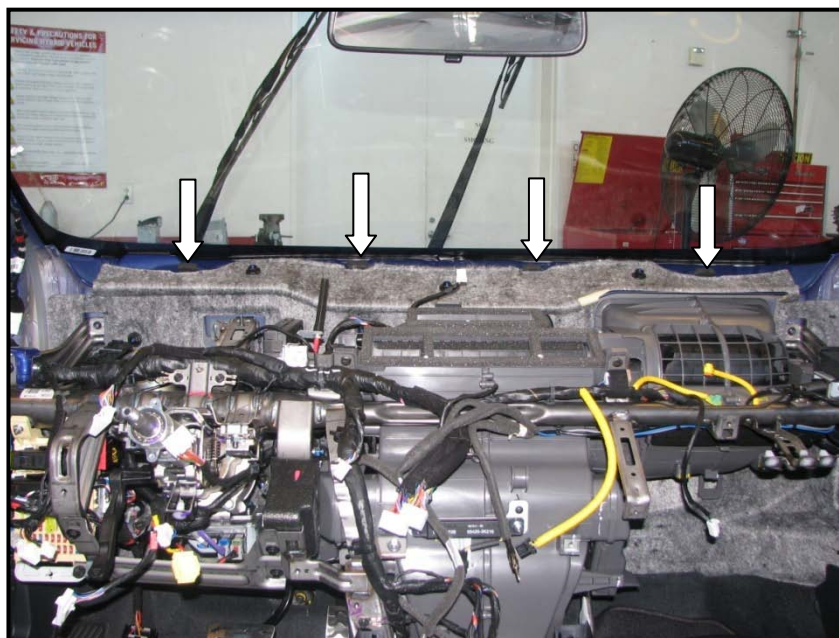
This bulletin provides information related to Rio (UB) vehicles produced from Start of production to November 11, 2011 that may experience a squeaking, rubbing or creaking noise emitting from the upper instrument panel pad area during normal driving conditions or while going over bumps or rough roads. These noises may be more prevalent during colder temperatures. To repair this condition, perform the following procedure outlined in this TSB.

Instrument panel pad contact tabs (arrows) will require a felt type insulation material applied to each of the four (4) tabs.

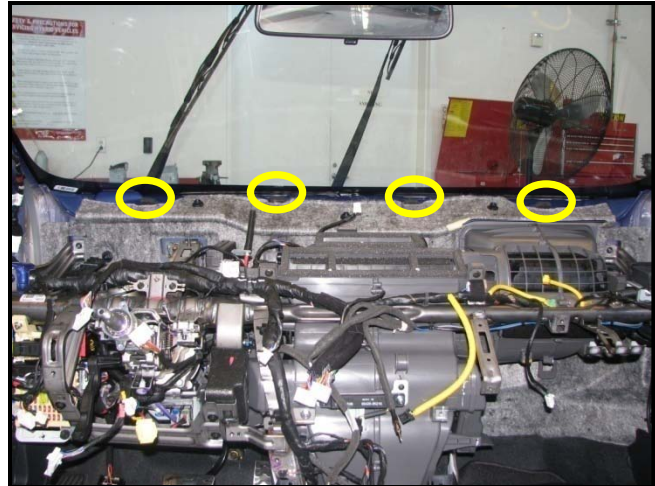
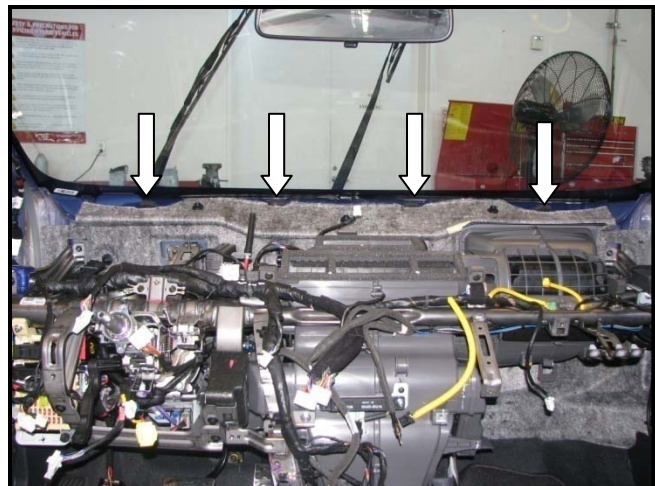
Instrument panel pad assembly is shown removed (photo on the right) to allow access to the four (4) dash contact tabs as indicated in the circle.

3. Locate the four (4) contact tabs (arrows) after instrument panel pad assembly has been removed.
