Safety Recall

Code: 34F6

**Subject: 2013-2014 MY Jetta Hybrid
7-Speed DSG® Auto Transmission w/Tiptronic®
(DQ-200 Direct-Shift Gearbox)**

December 06, 2013

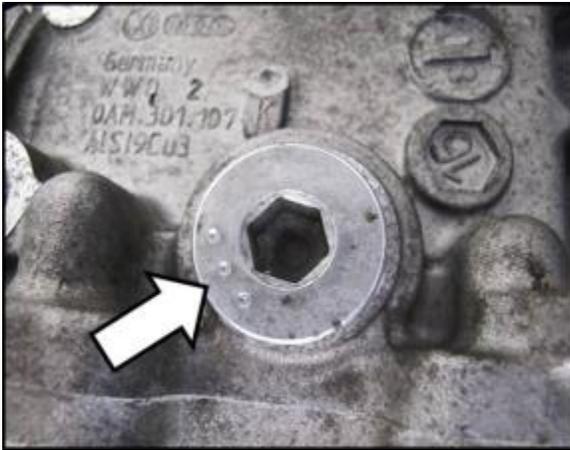
- Move the selector in the park "P" position.
- Raise vehicle on hoist.
- Inspect for three (3) punch marks located on the transmission drain plug as shown <arrow>:
 - If three (3) punch marks are present, continue to Section G to update software.
 - If three (3) punch marks are not present,

Continue to Section C to drain fluid
