# Service Bulletin

Bulletin No.: 17-NA-118

**Subject:** Information on Body Seam Locations as Possible Intrusion Areas for Water Leaks, Musty Odor, Wet Carpet and/or Water Leaking on Driver Side Floor

Brand:	Model:	Model Year:		VIN:		Engine:	Transmission:
		from	to	from	to		
Chevrolet	Trax	2016	2019			All	All

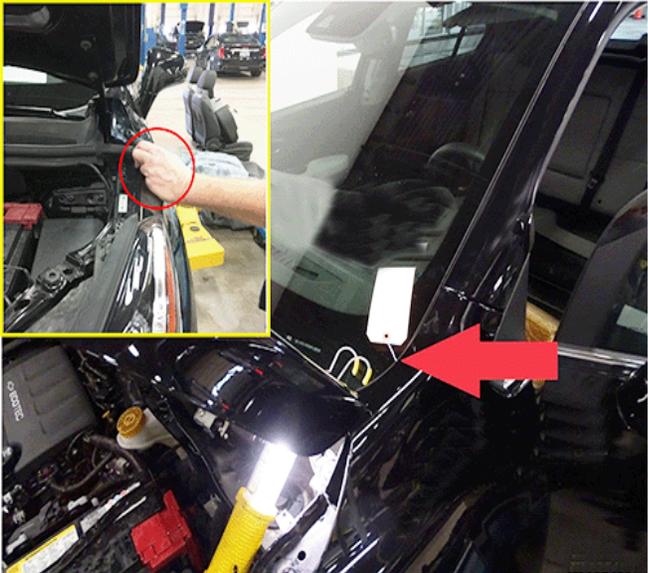
<p style="text-align: right;">4771191</p> <p>The cause of the condition may be voids in one or several body seam areas. The tag/wire noted by the arrow in the graphic above is pointing to one of the more common locations at the driver A-pillar.</p>
<b>Correction</b>	Using Kent Automotive High-Tech™ Clear Seam Sealer, or equivalent, reseal the body seam areas referenced in the Service Procedure below.

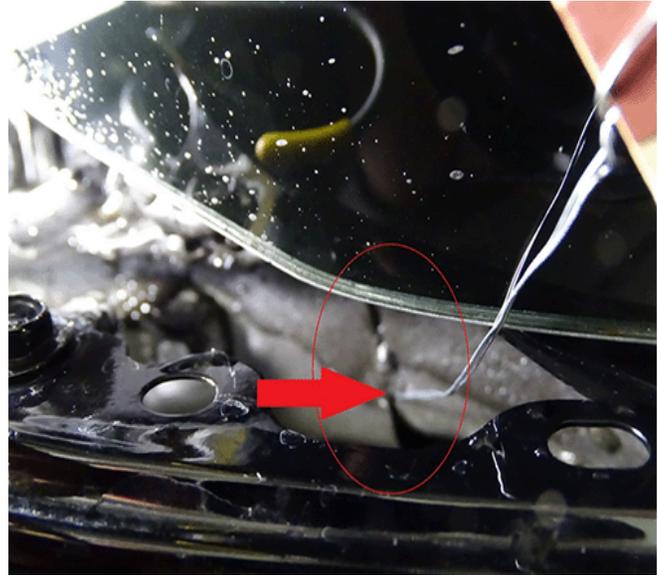
4771197

- Inspect the driver side upper hinge pillar seam (below the windshield edge, behind the hood hinge), again shown by the tag/wire in the graphic above.

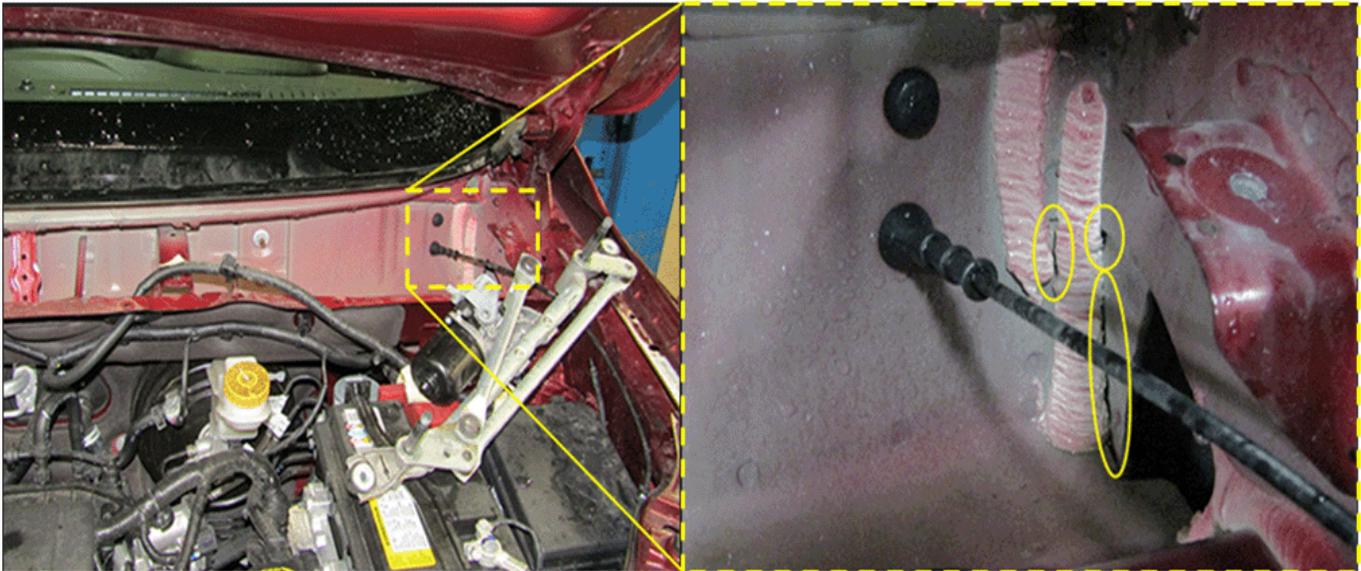
4771199

- Inspect the vertical body seam in the cowl area, shown circled in the graphic above.

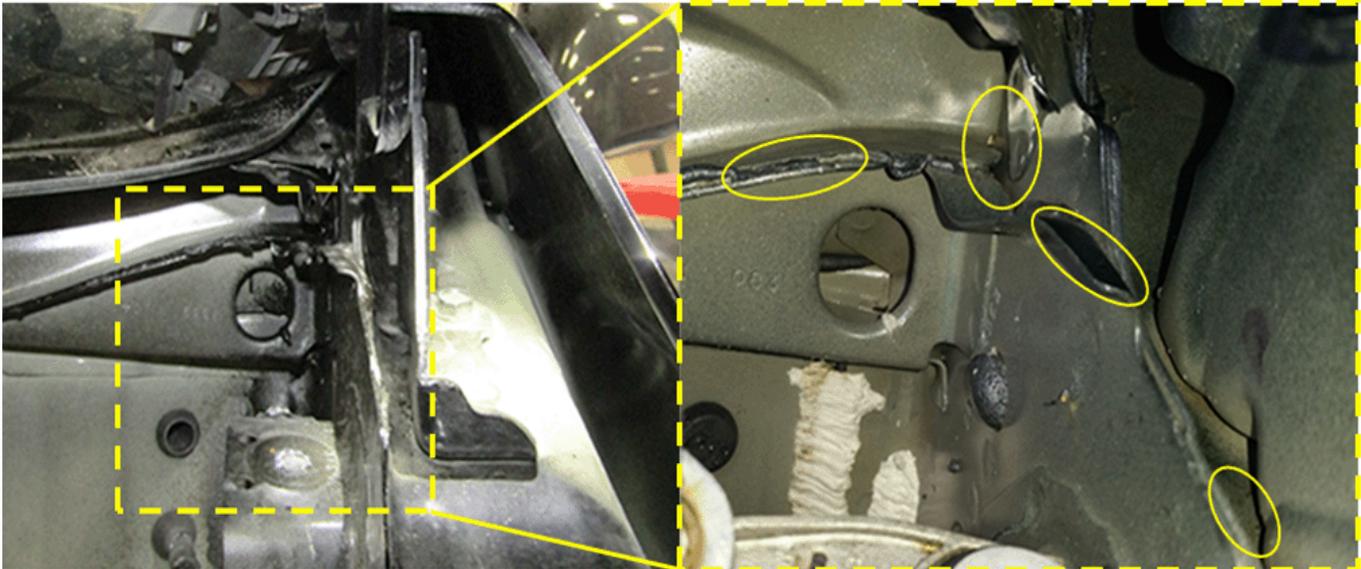
4839809

- Also inspect the horizontal seams shown circled in the graphic above.
